KSC Ice/Frost/Debris Assessment For Space Shuttle Mission STS-29R

Charles G. Stevenson
NASA/Kennedy Space Center

KSC ICE/FROST/DEBRIS ASSESSMENT
FOR
SPACE SHUTTLE MISSION
STS-29R
MARCH 13, 1989

Approved:
April 30, 1989

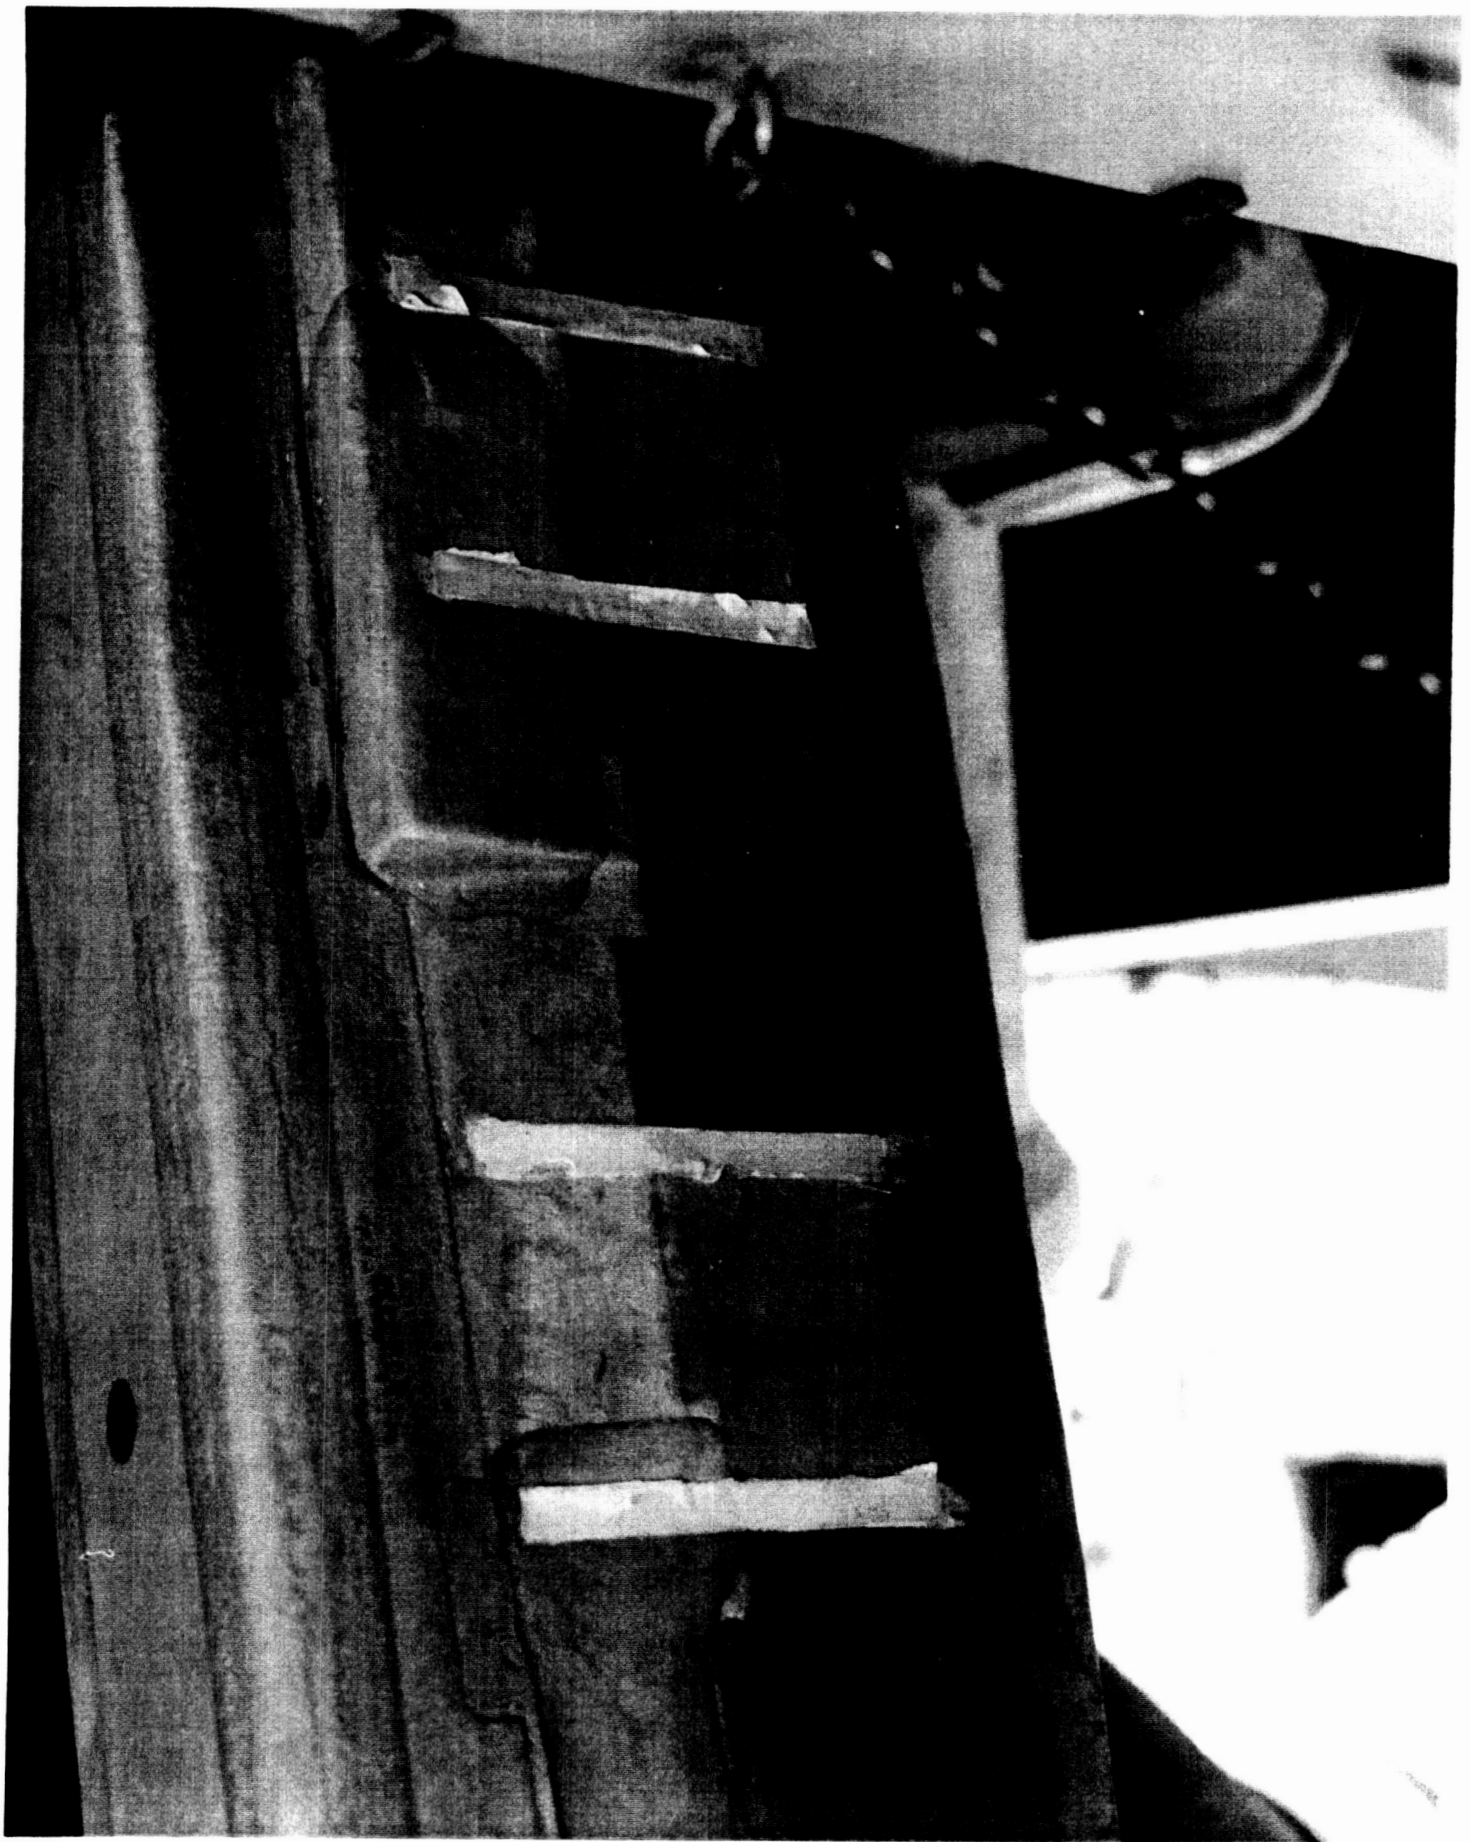
K5NA REAPPLIED DAY BEFORE LAUNCH. CURE TIME WAS WAIVED.
NOTE JOINT PROTECTION SYSTEM CORK VENT HOLES

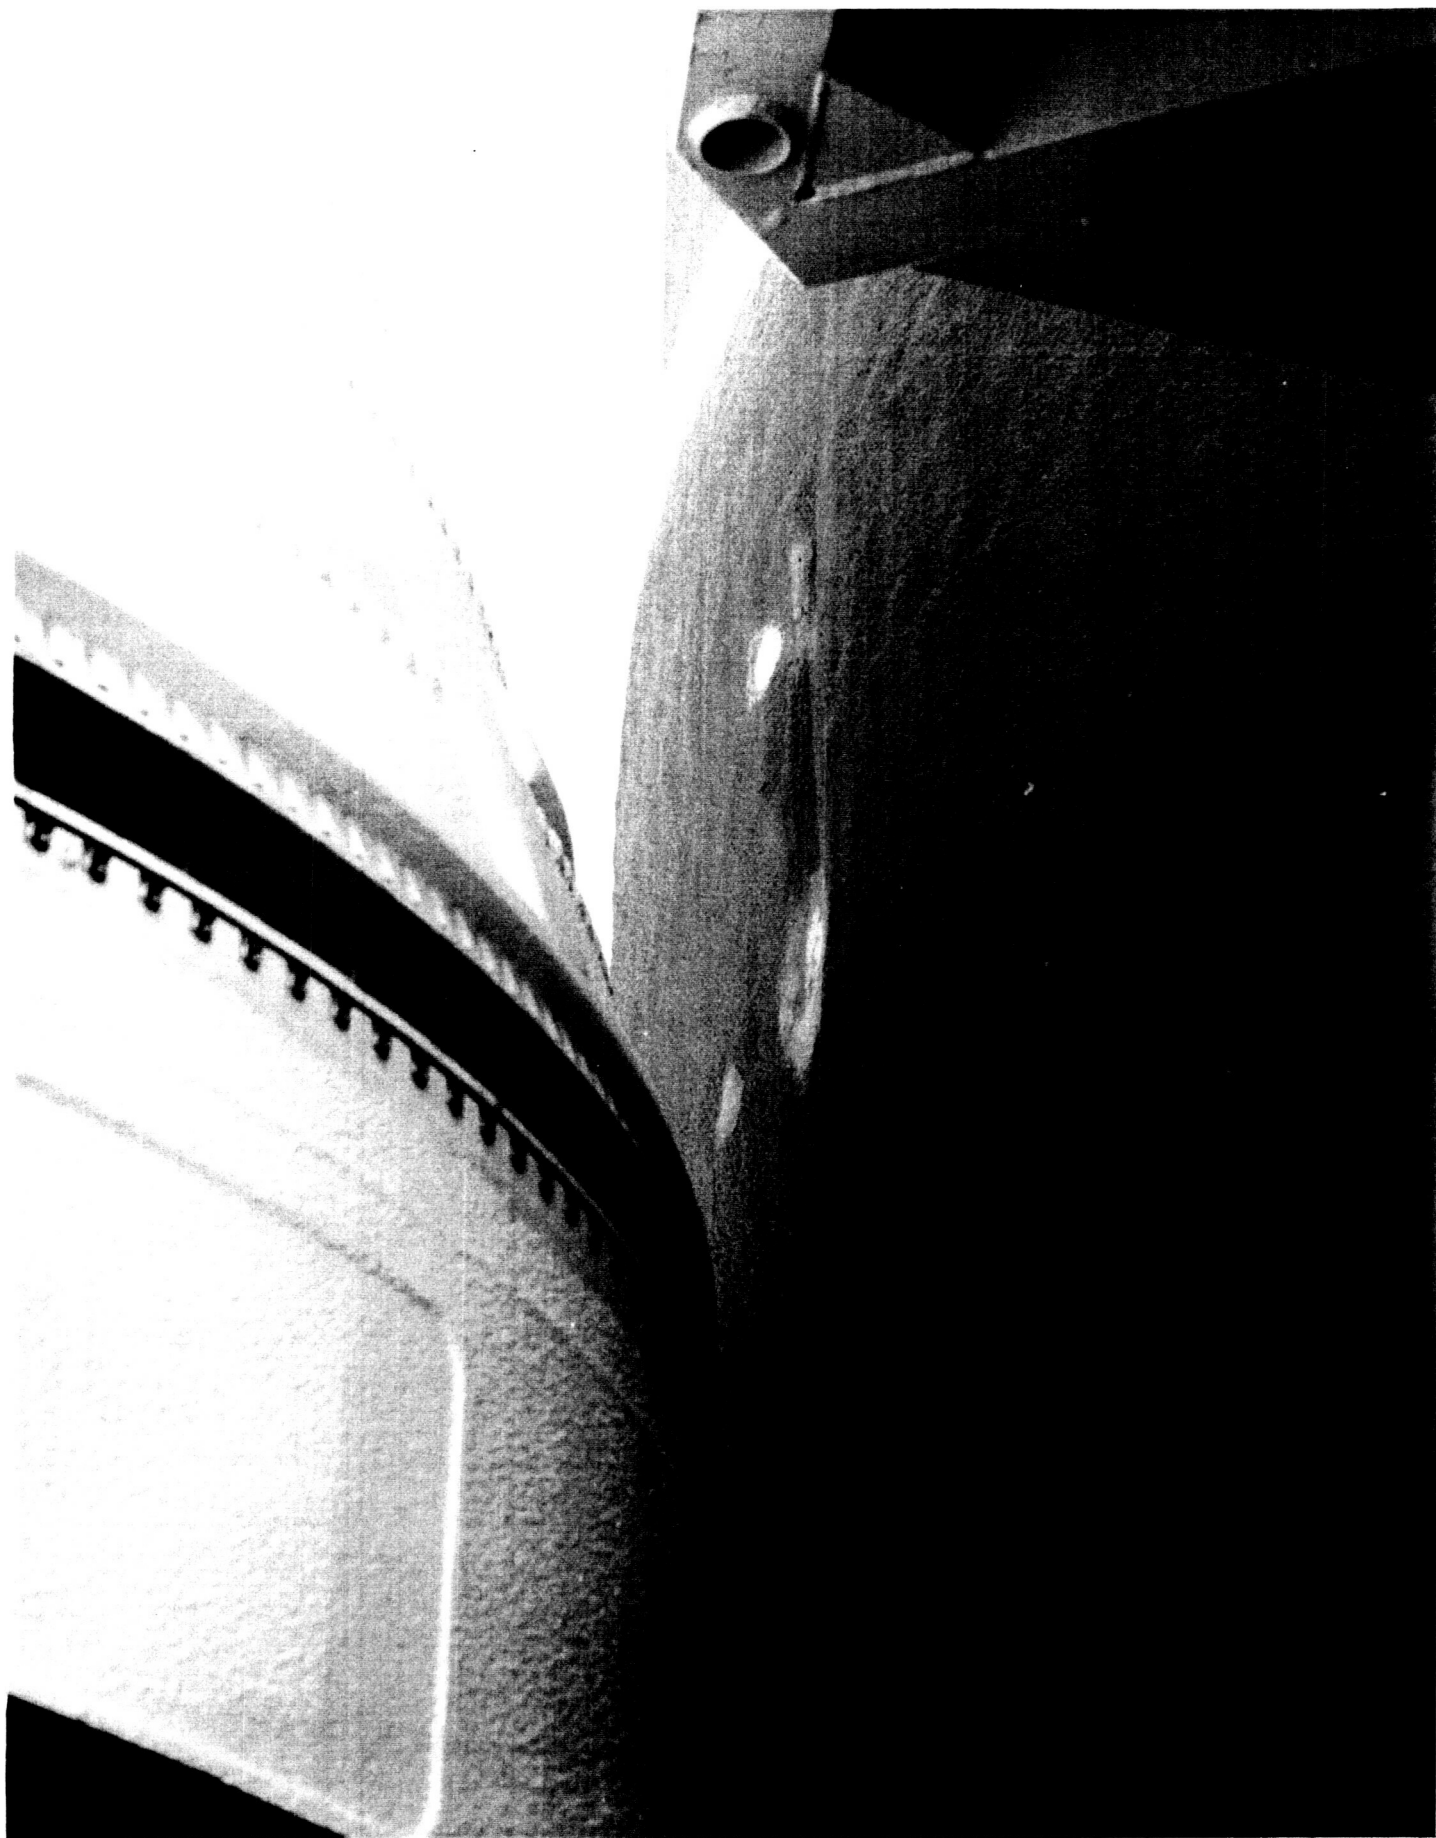
There were no major vehicle anomalies. The External Tank hydrogen fire detection system (butcher paper) was missing from the vertical strut at position #3 and #4, and severely ripped at positions #1, #2, and #6. This occurred during high winds associated with a recent weather front and was documented on PR-ET-36-TS-0108.

MISSING PIECES OF BUTCHER PAPER FROM HYDROGEN FIRE
DETECTION SYSTEM DUE TO HIGH WINDS

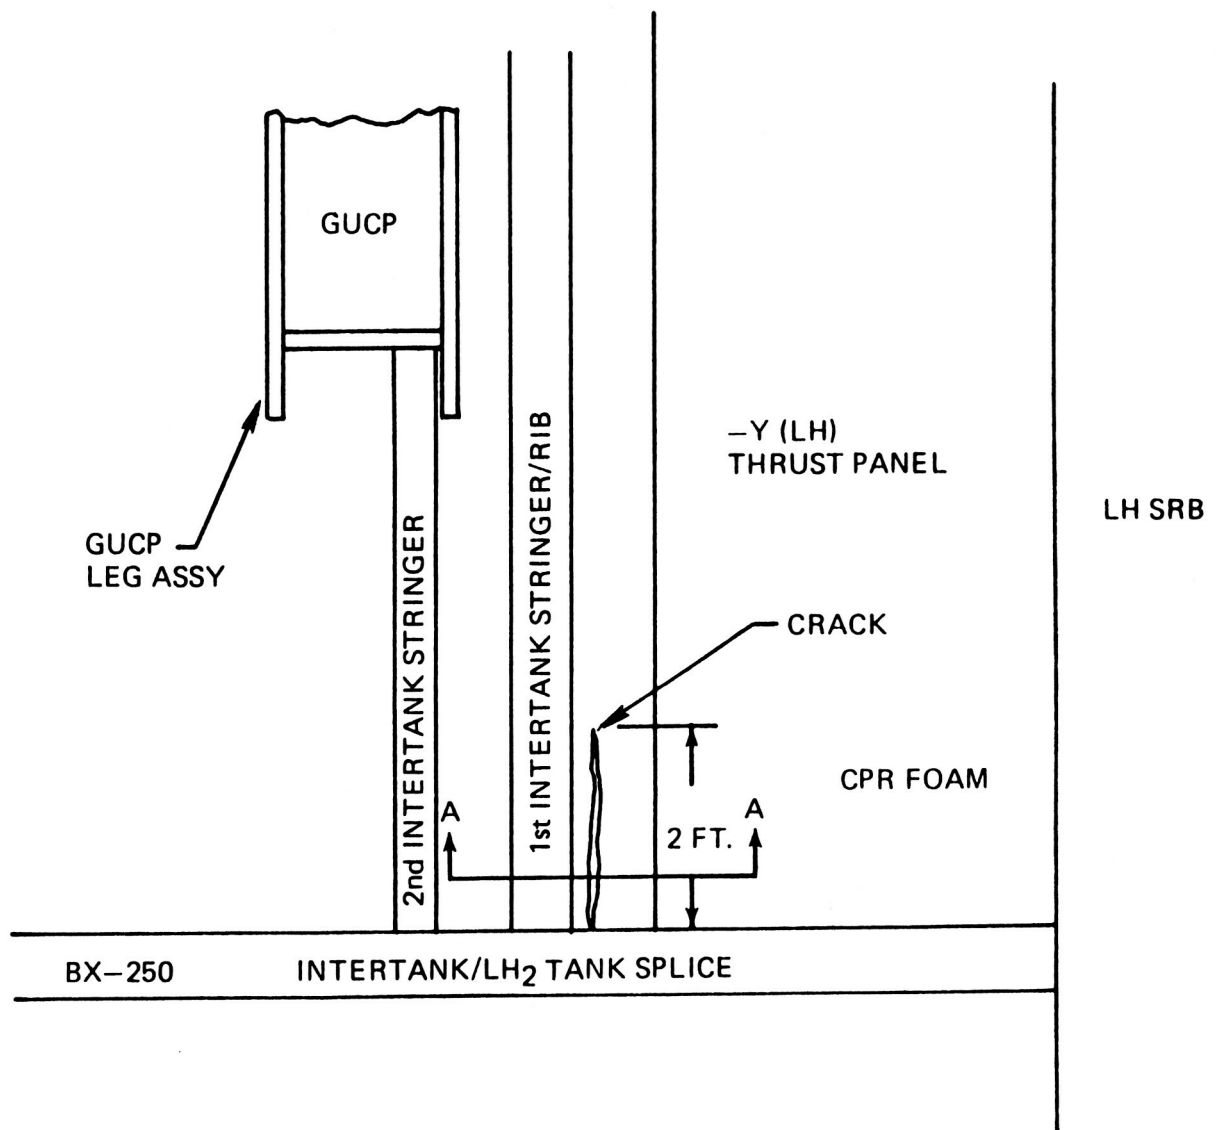
FIGURE 6. Crack in ET Intertank TPS

IPR 29RV-0294 was written against a 2 foot longitudinal crack, 1/8-inch wide, in the intertank CPR foam beginning at the LH2 tank splice. The crack was located in the first stringer valley adjacent to the -Y thrust panel. There was no frost in the crack and no offset across the crack. This type of TPS crack is within the database from previous flights, was not a thermal or debris concern, and did not violate the NSTS-08303 criteria.

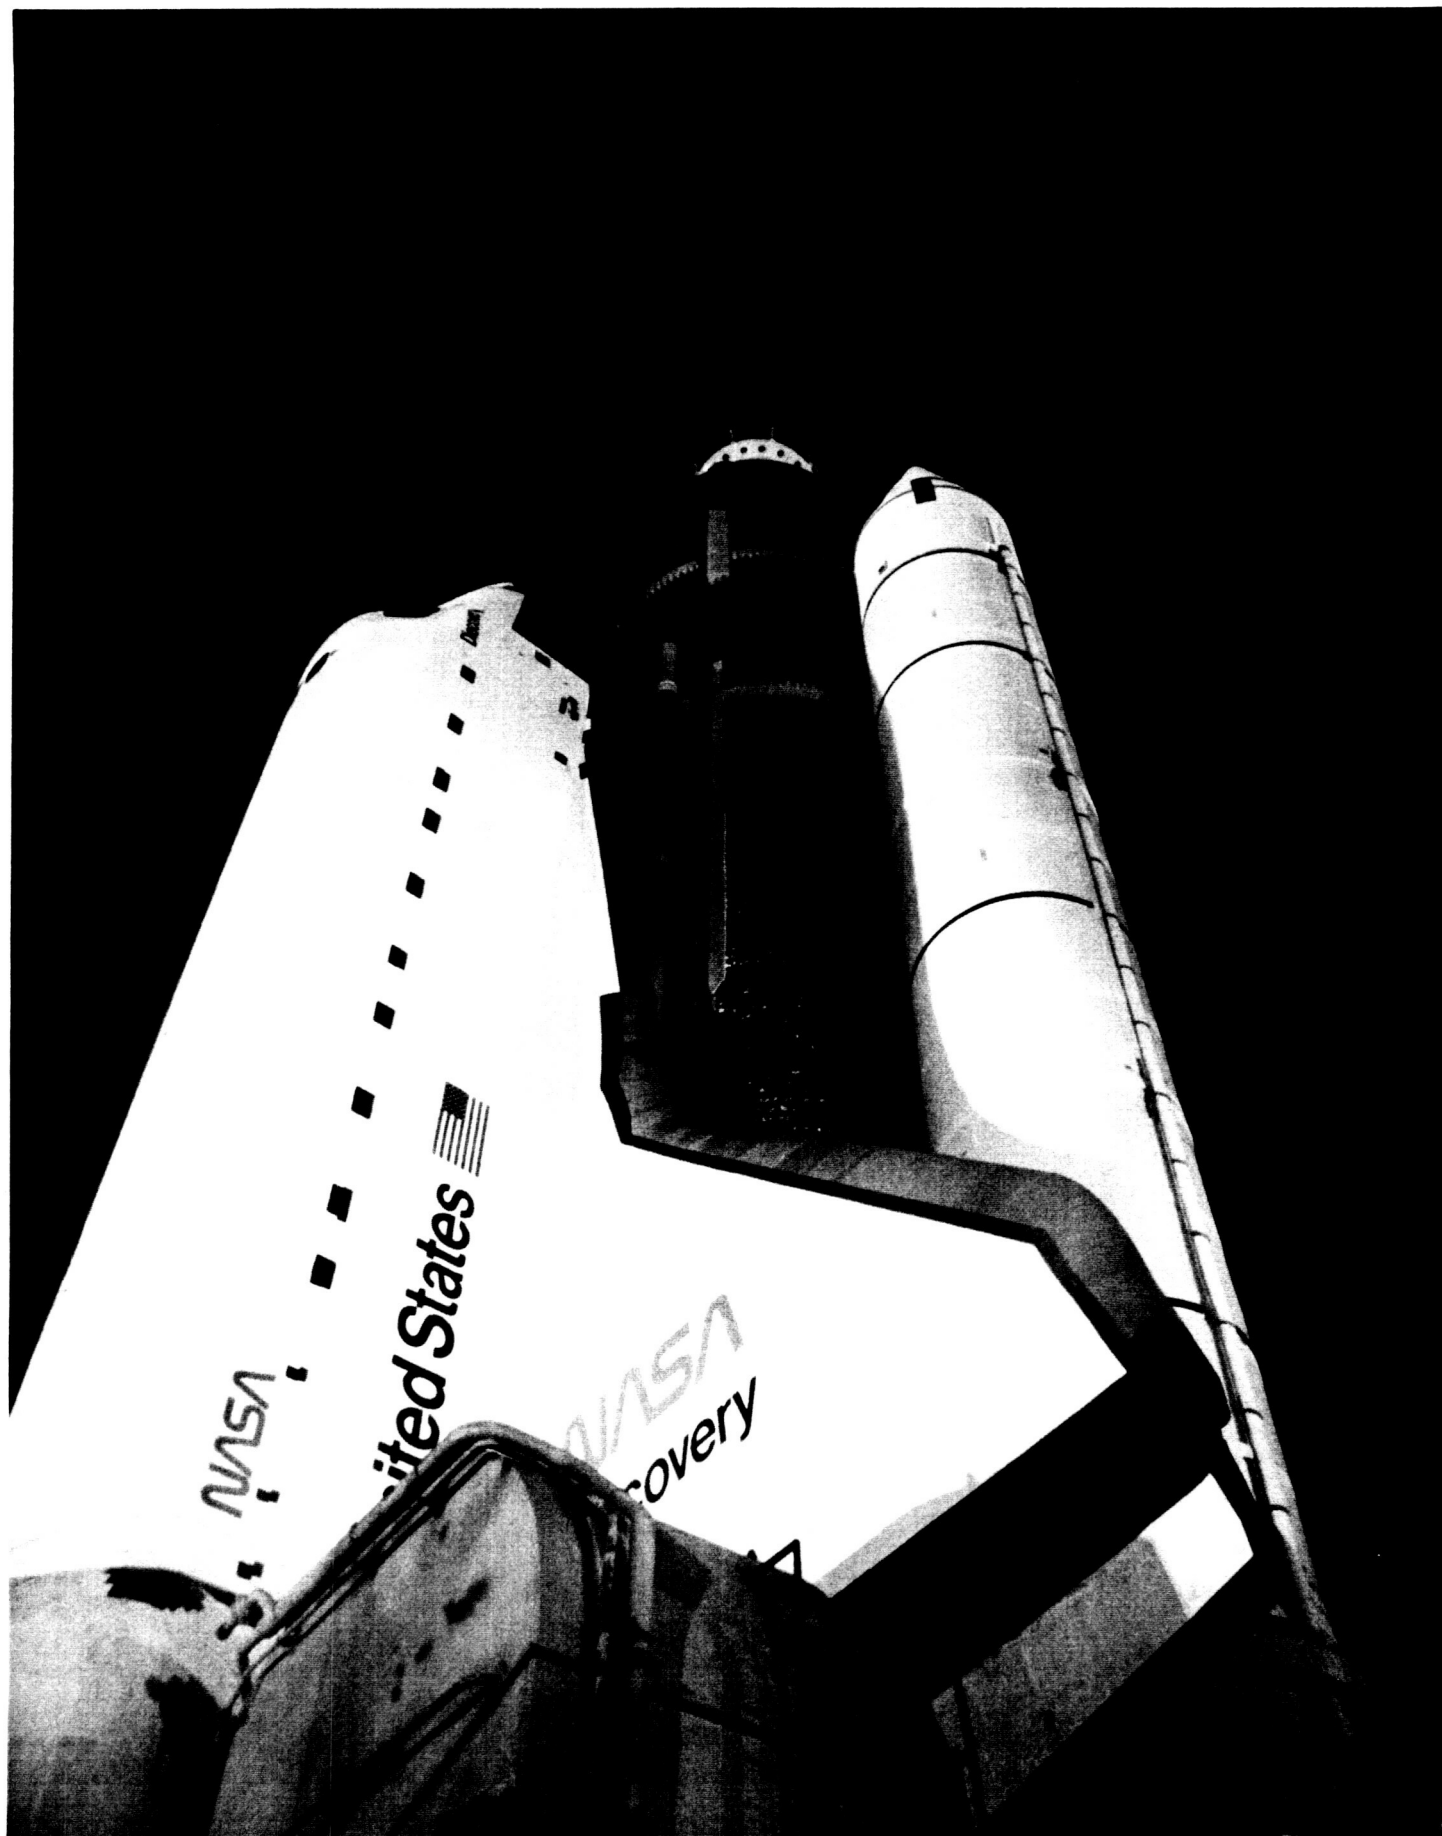
OVERALL VIEW OF EXTERNAL TANK +Y+Z QUADRANT
ACREAGE FROST WAS PRESENT ON LH2 TANK

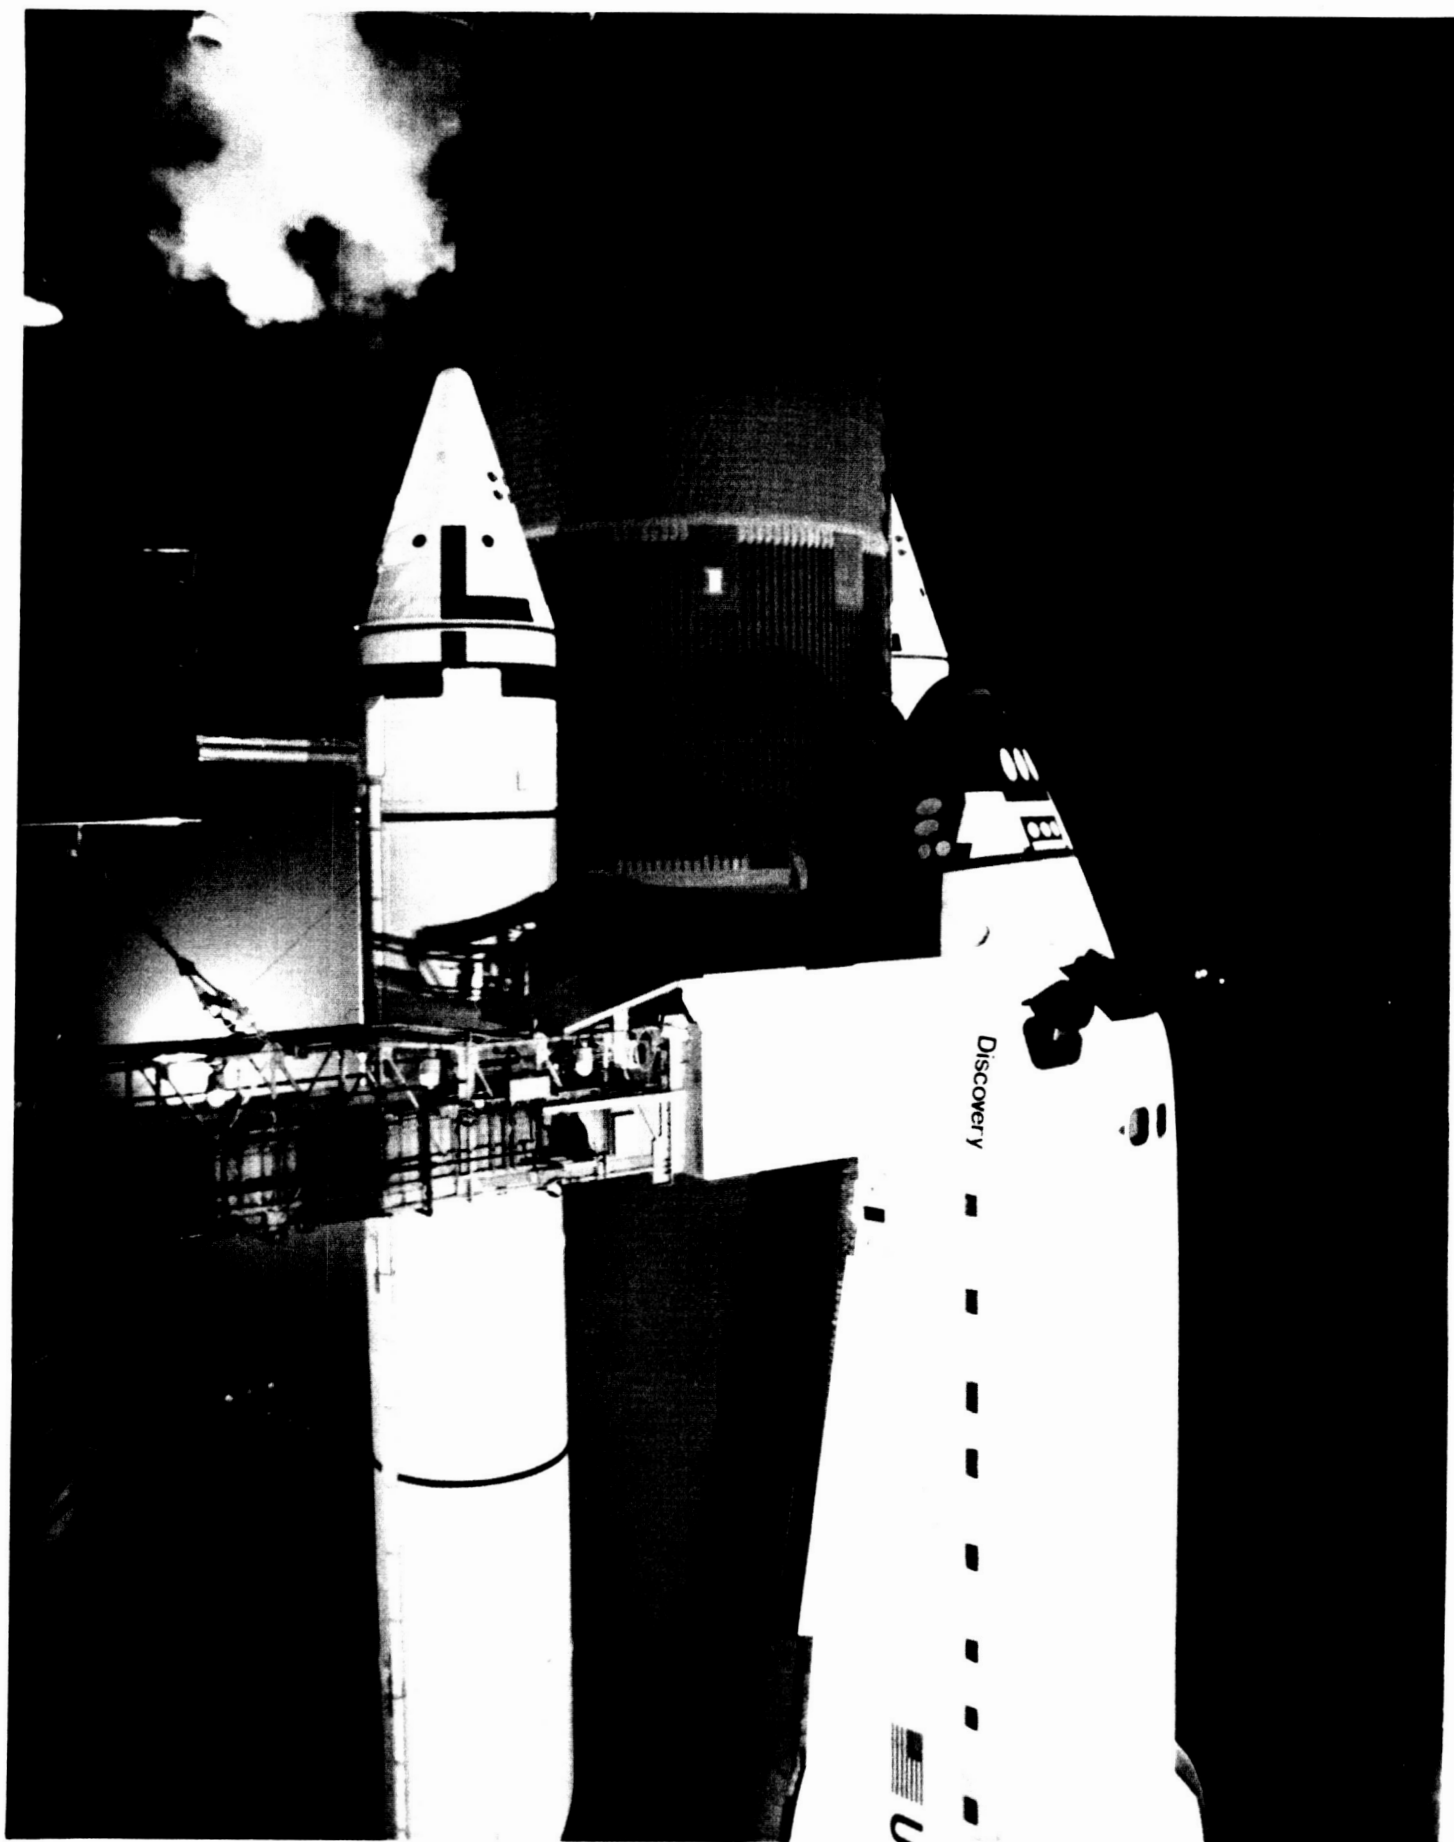
~~ORIGINAL PAGE IS~~ OVERALL VIEW OF EXTERNAL TANK -Y+Z QUADRANT
OF POOR QUALITY NO ACREAGE FROST HAD ACCUMULATED

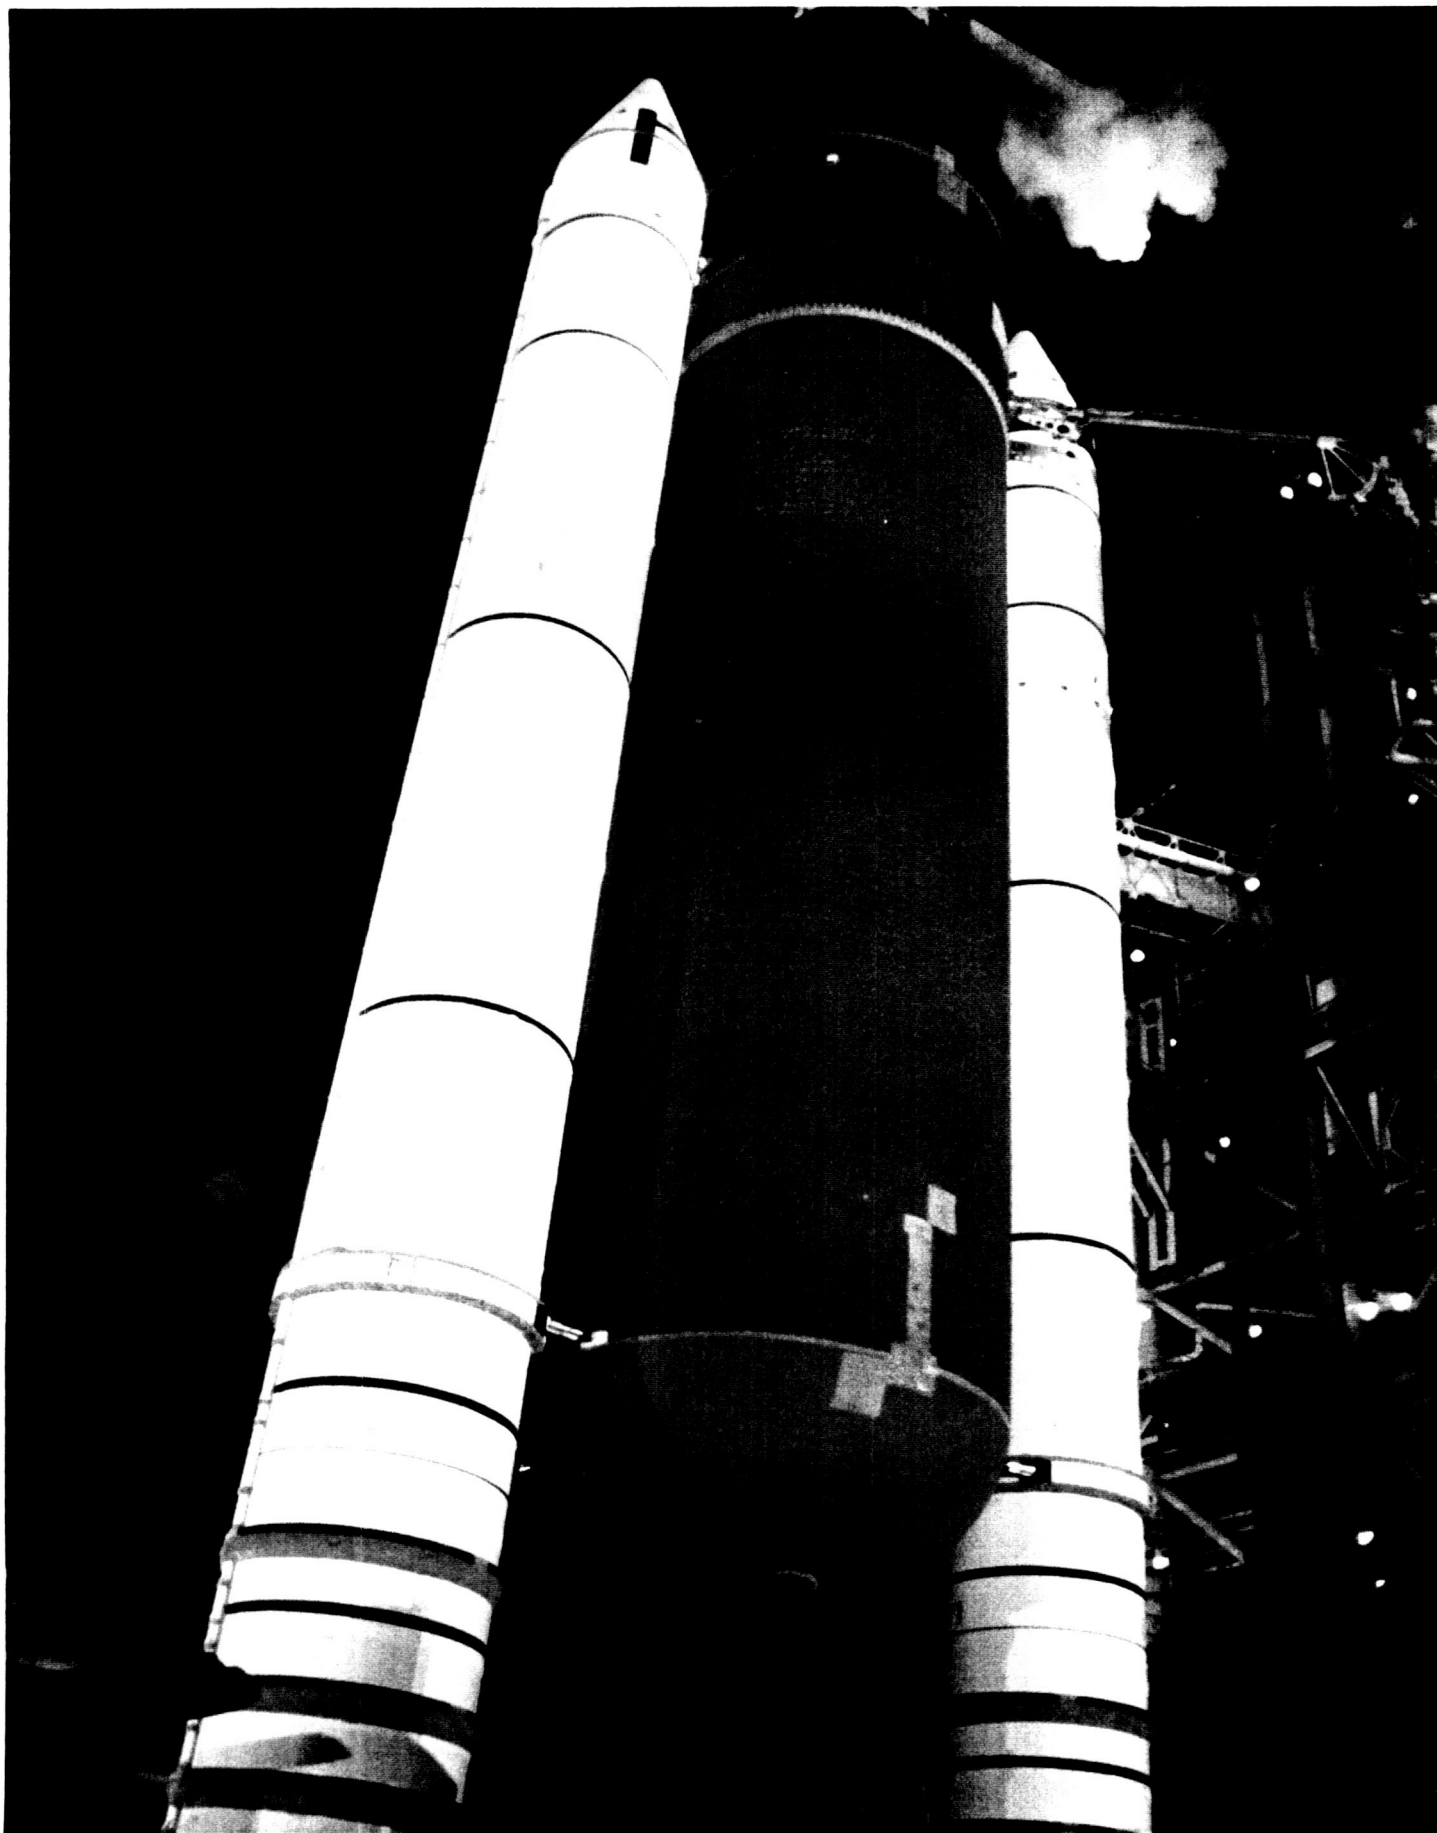
OVERALL VIEW OF EXTERNAL TANK -Z SIDE
ACREAGE FROST HAD ACCUMULATED ON LH2 TANK

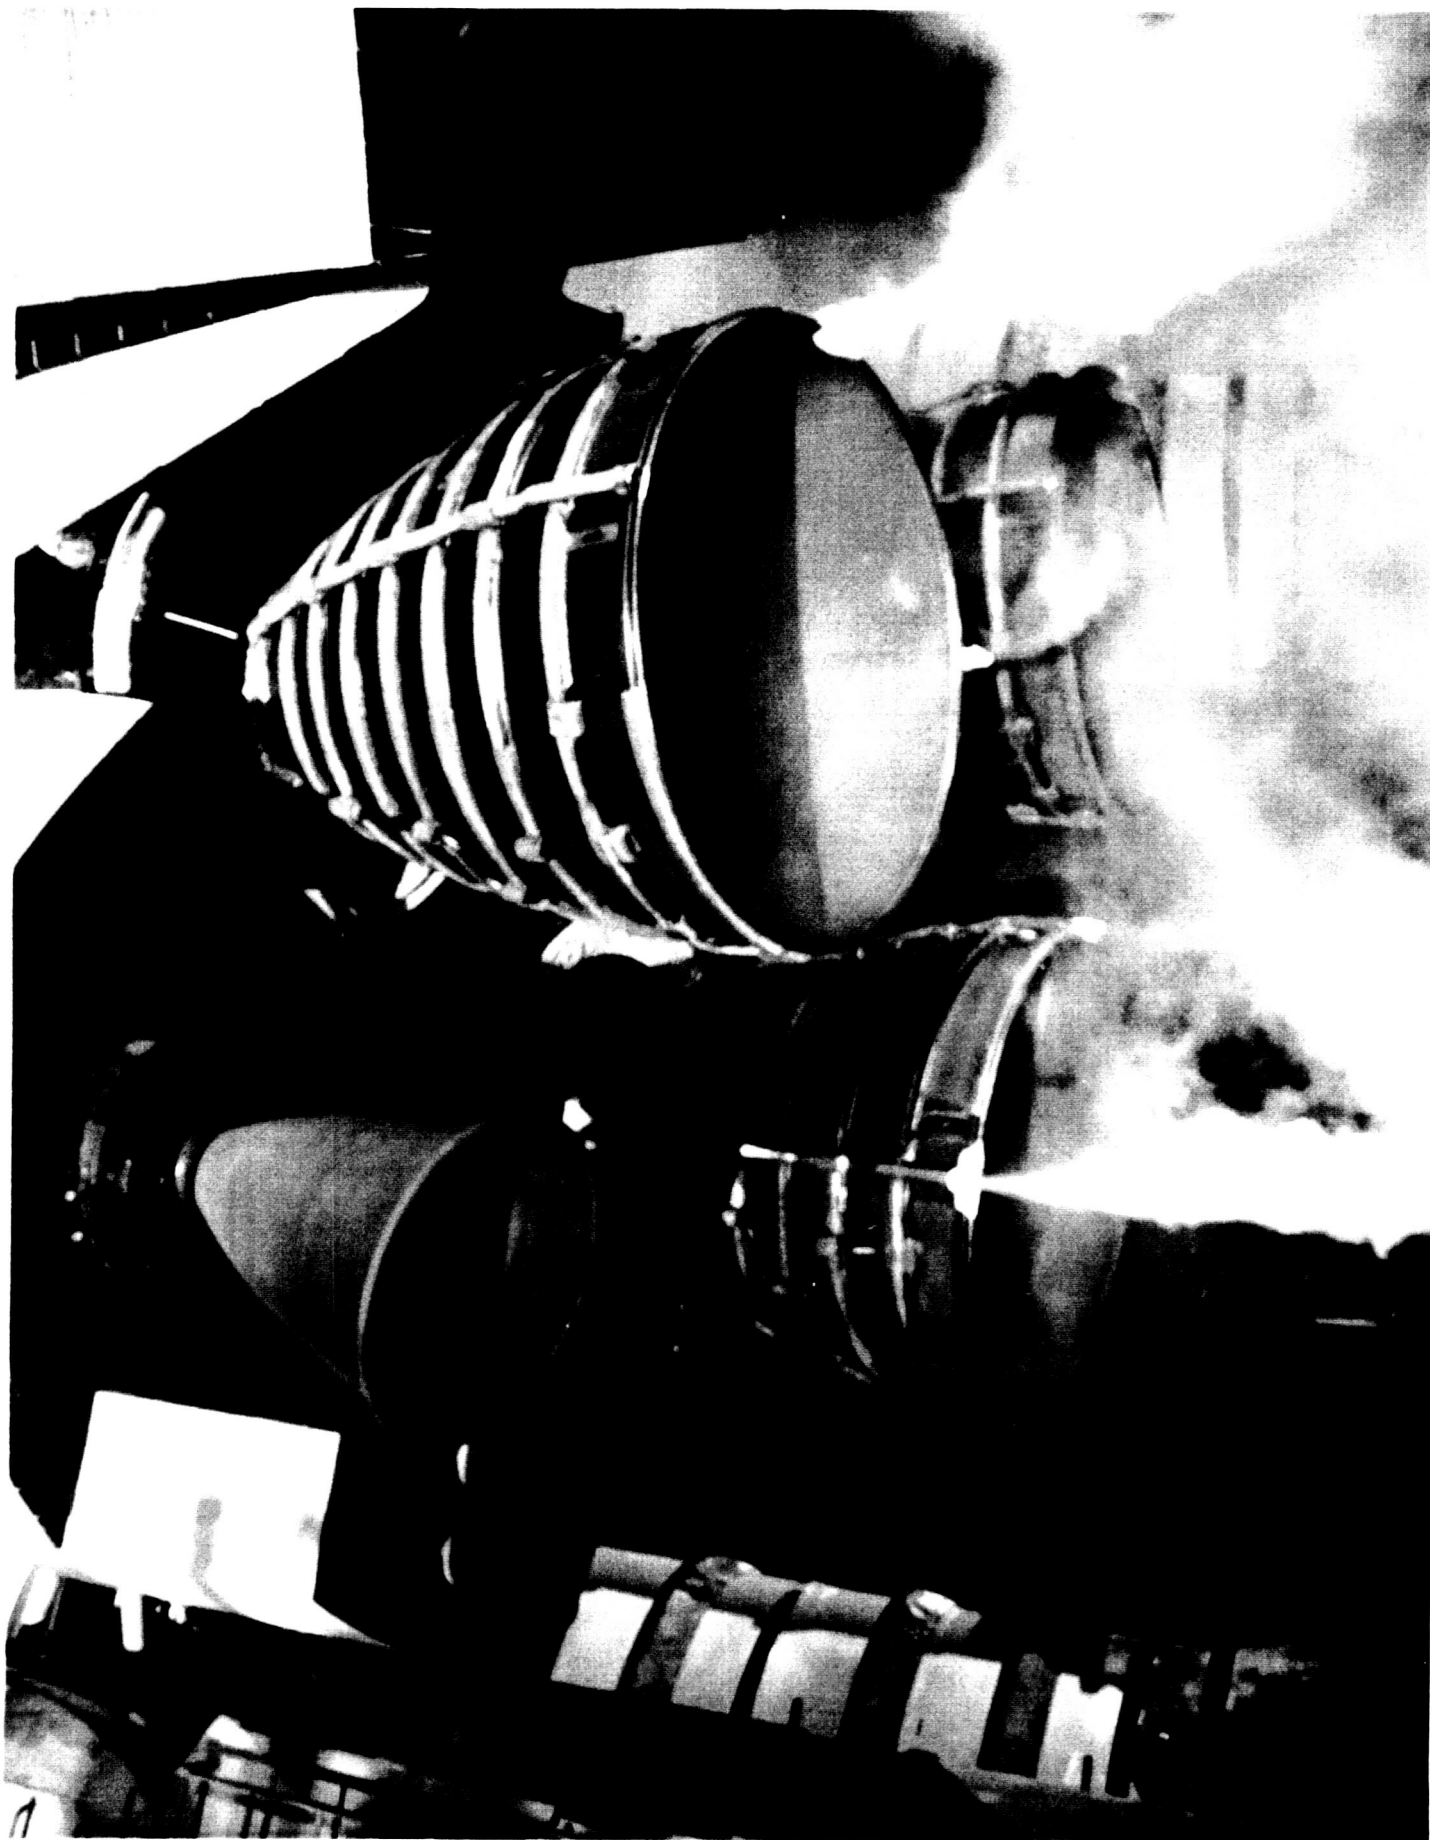
OVERALL VIEW OF SHUTTLE MAIN ENGINES. FROST HAS FORMED
AT NOZZLE TO ENGINE MOUNTED HEATSHIELD INTERFACES

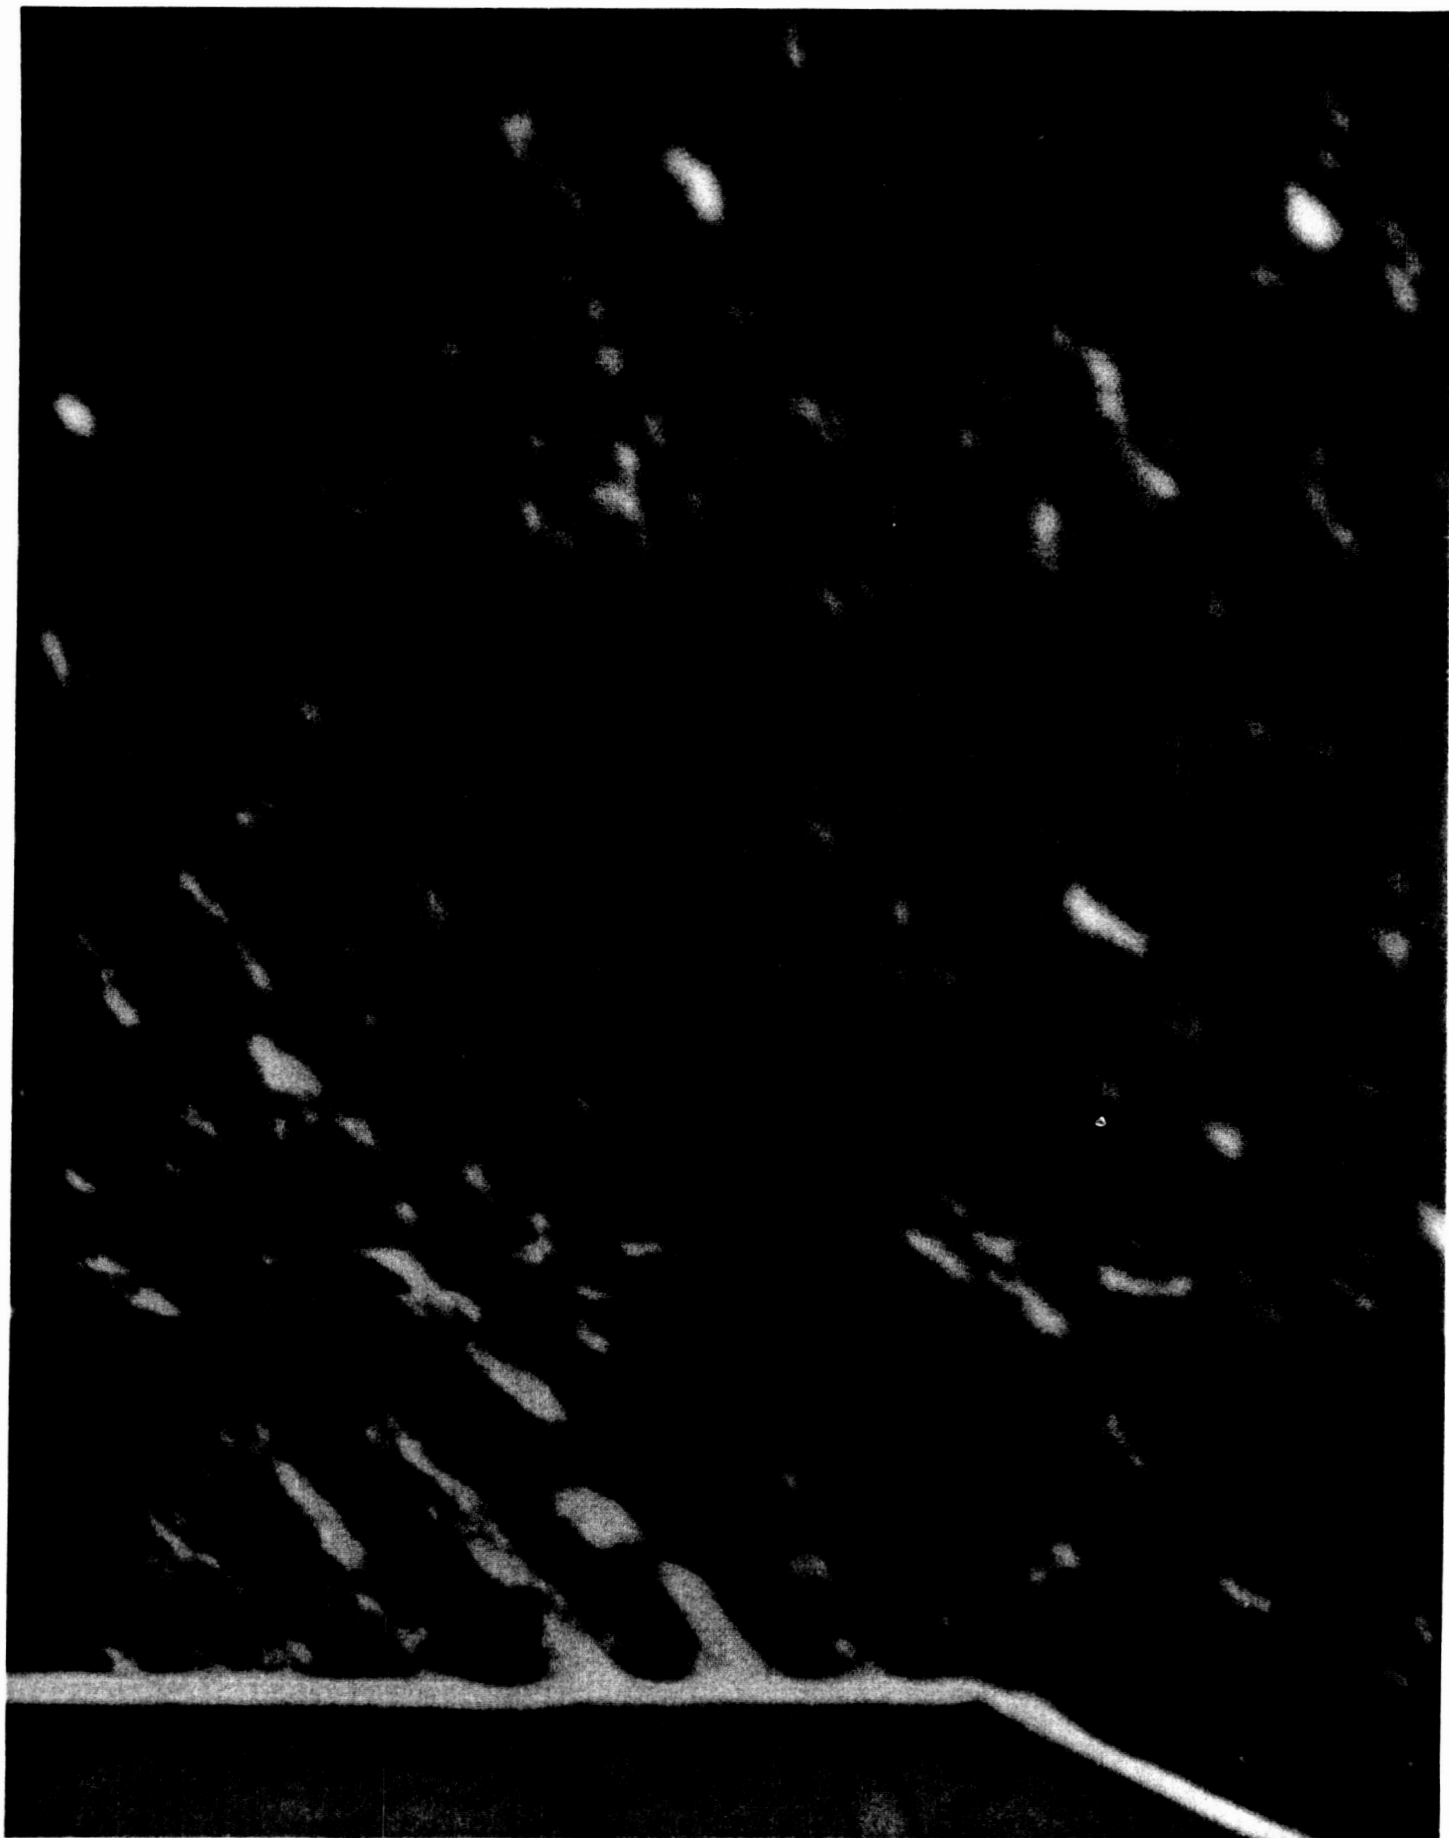
Less than typical accumulations of ice/frost were present in the LO2 feedline bellows and support brackets and on the LO2 ET/ORB umbilical. Acreage frost had formed on the LH2 tank +Y side. The frost, which was less than 1/16-inch thick and acceptable per the nomographs/NSTS-08303 criteria, was later diminished by the sun and wind, and virtually gone by launch.

LH2 TANK ACREAGE FROST WAS ACCEPTABLE PER
THE NOMOGRAPHS AND NSTS-08303 CRITERIA

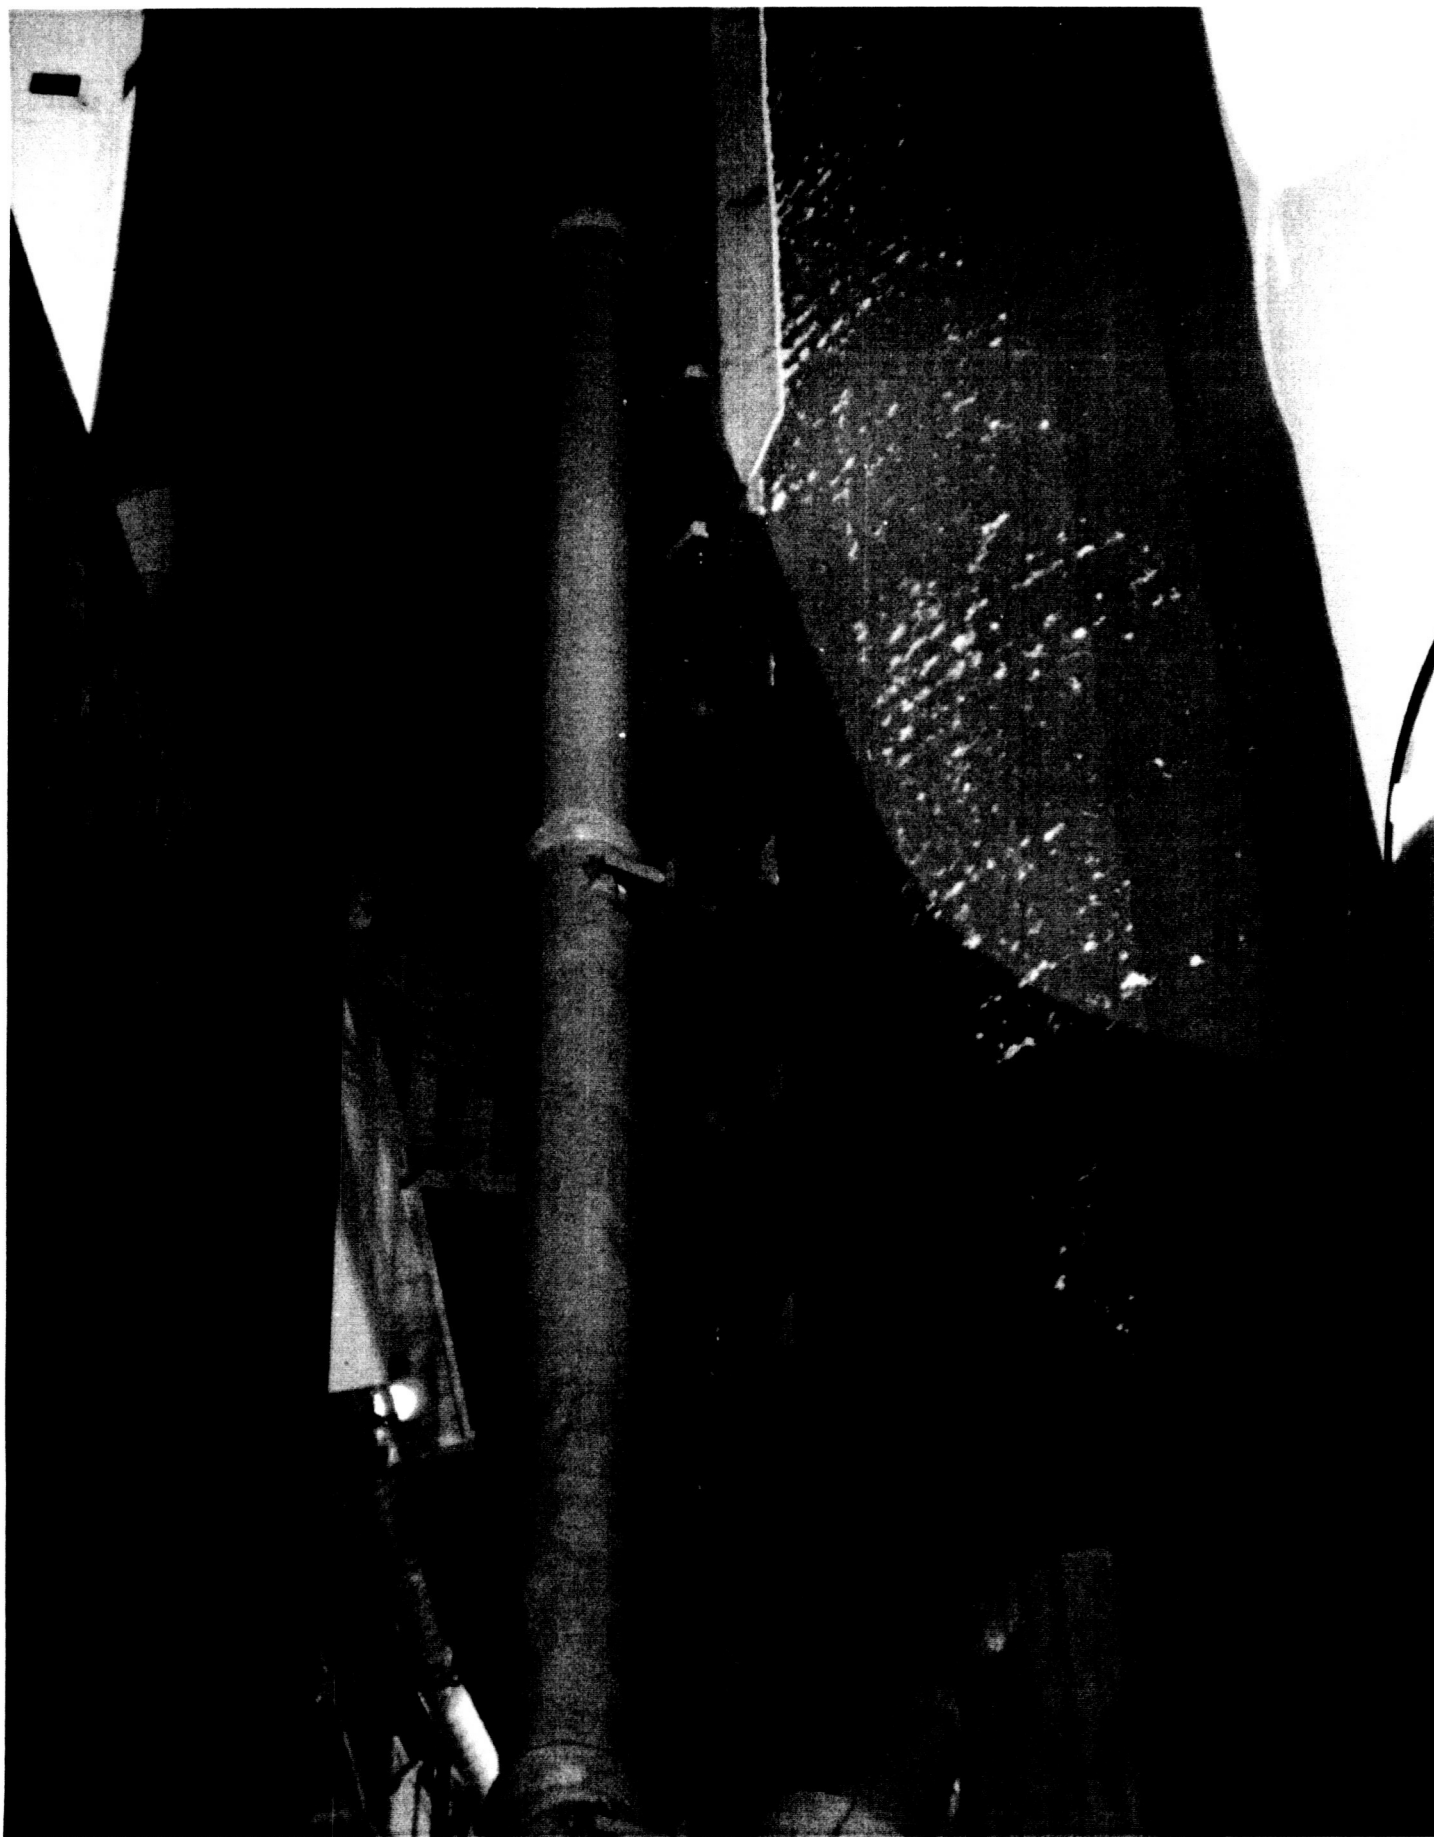
ACREAGE FROST ON LH2 TANK +Y+Z QUADRANT
HAD MELTED PRIOR TO LAUNCH
